XRD-57

AEC RESEARCH AND DEVELOPMENT REPORT

USS BARROW (APA61)

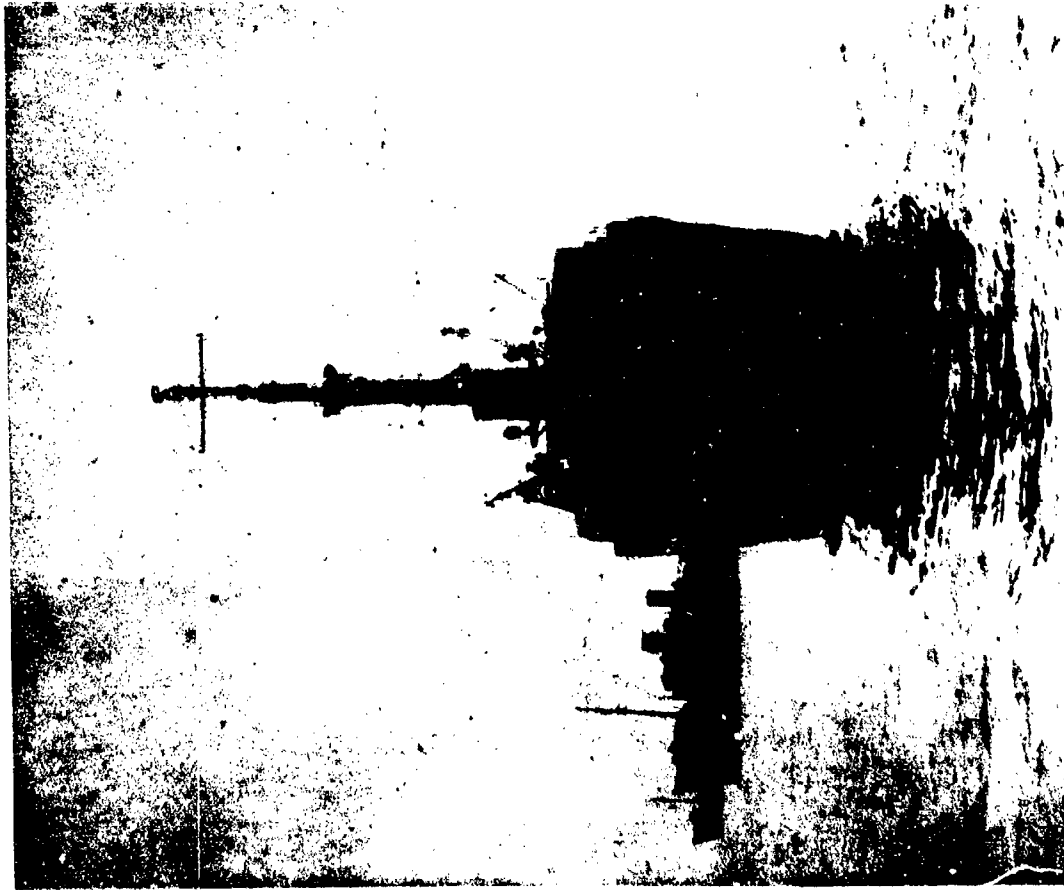
AA-CR-227-49-126. View from dead ahead after Test A.

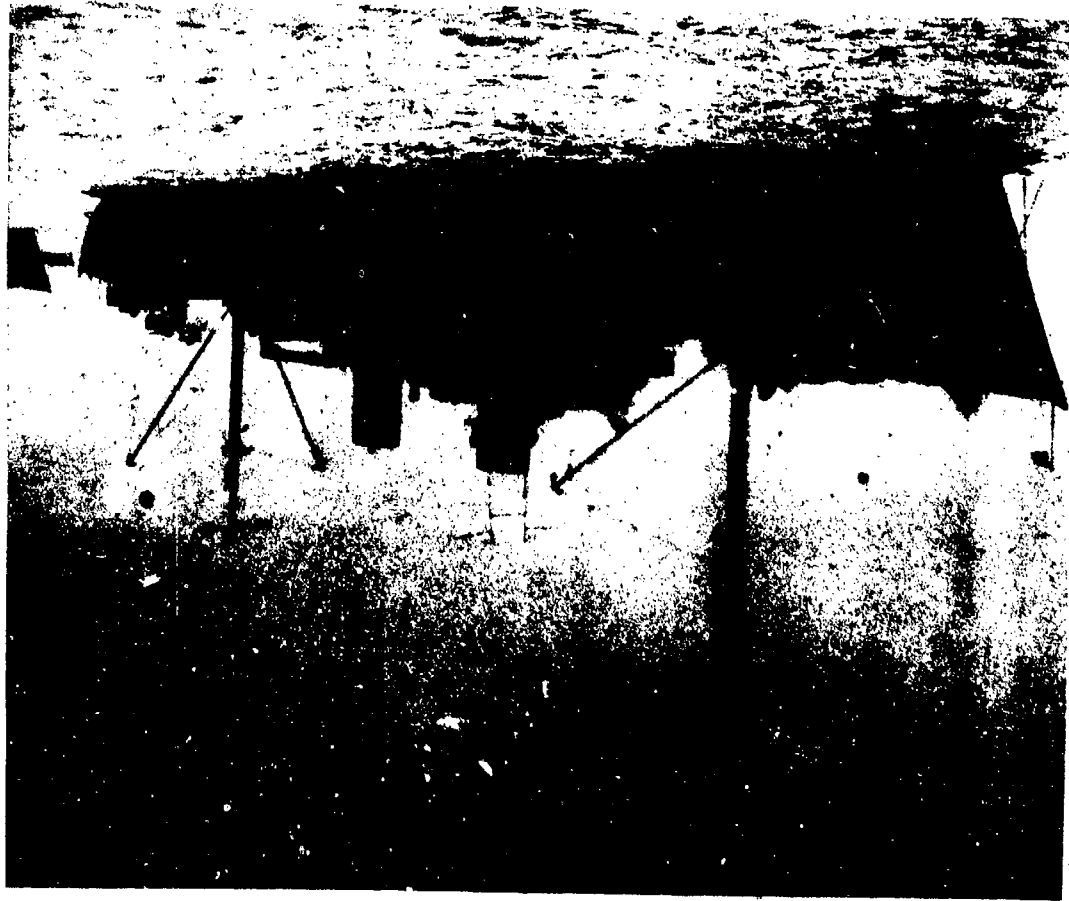
AA-CR-227-49-127. View from off port bow after Test A.

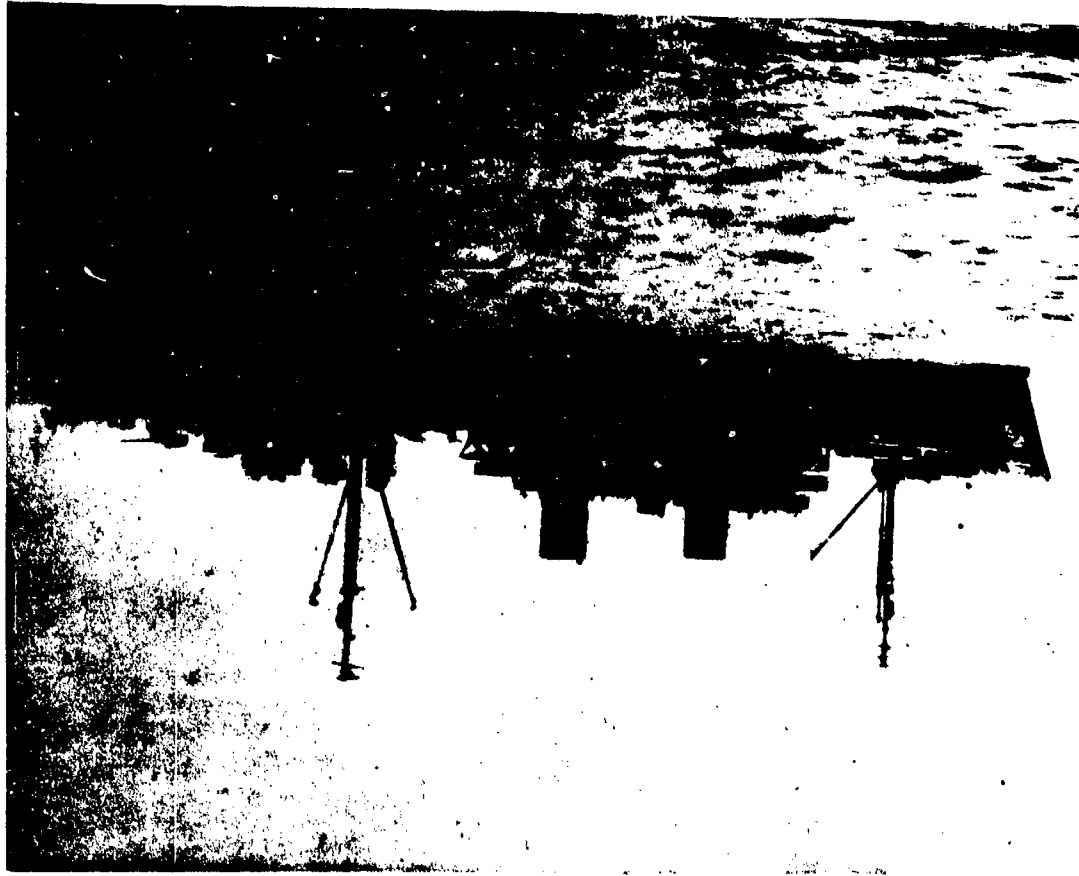
AA-CR-227-49-128. View from off port quarter after Test A.

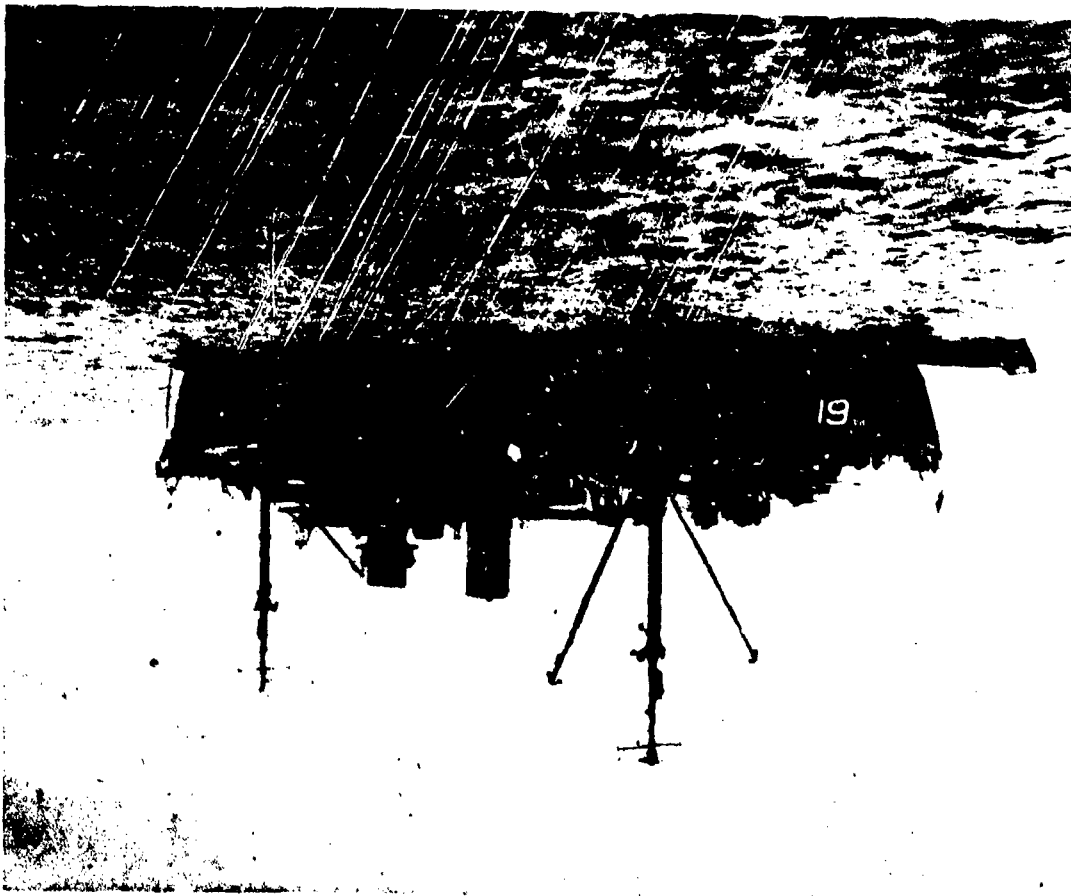
AA-CR-227-49-122. View from off starboard quarter after Test A.

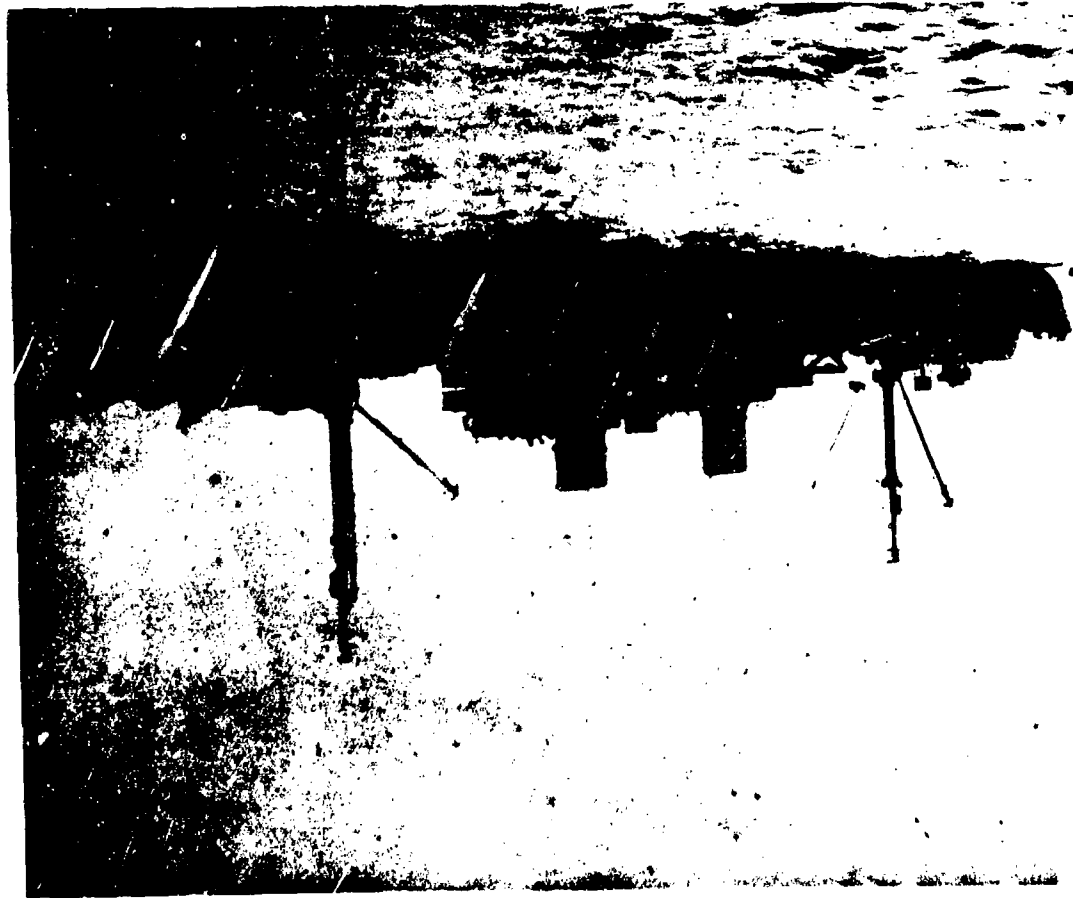
AA-CR-227-49-125. View from off starboard bow after Test A.

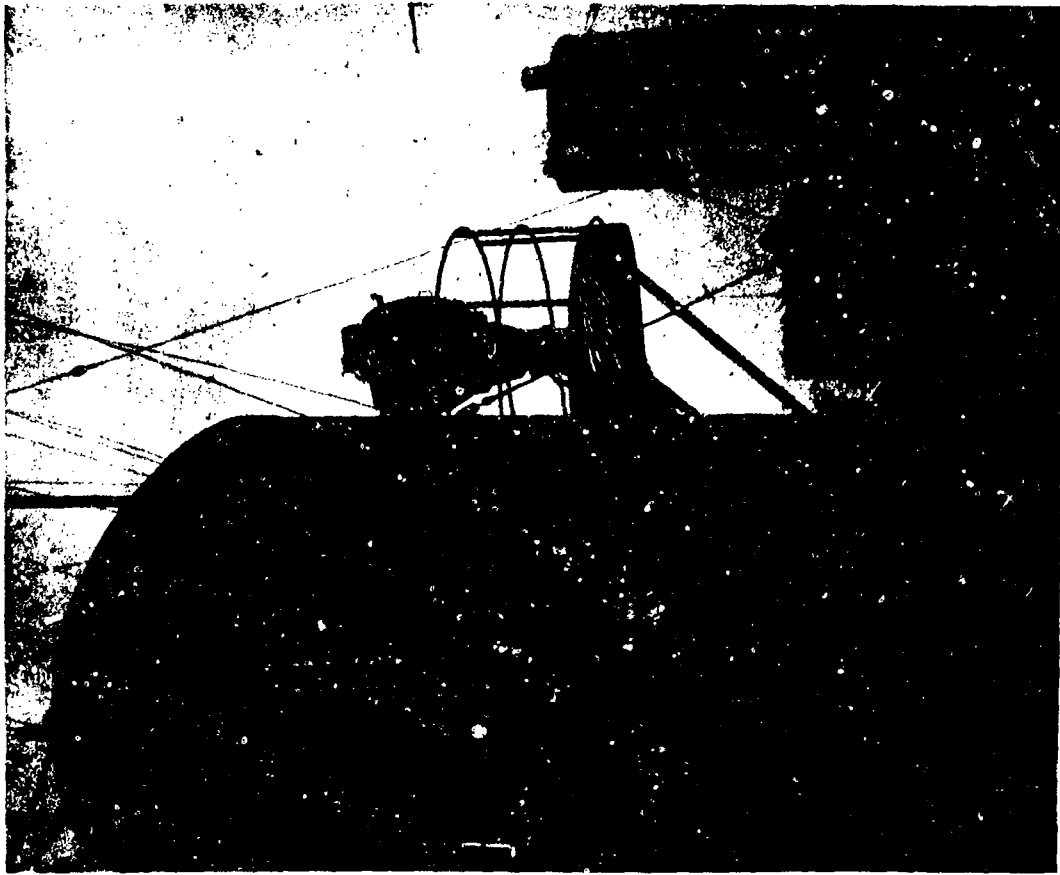
AA-CR-82-1913-3. Looking aft and inboard on port side of the signal bridge at slightly damaged flagtag and ladder to searchlight platform.
